Answers To What Could Possibly Go Wrong?

Photo Challenge #2

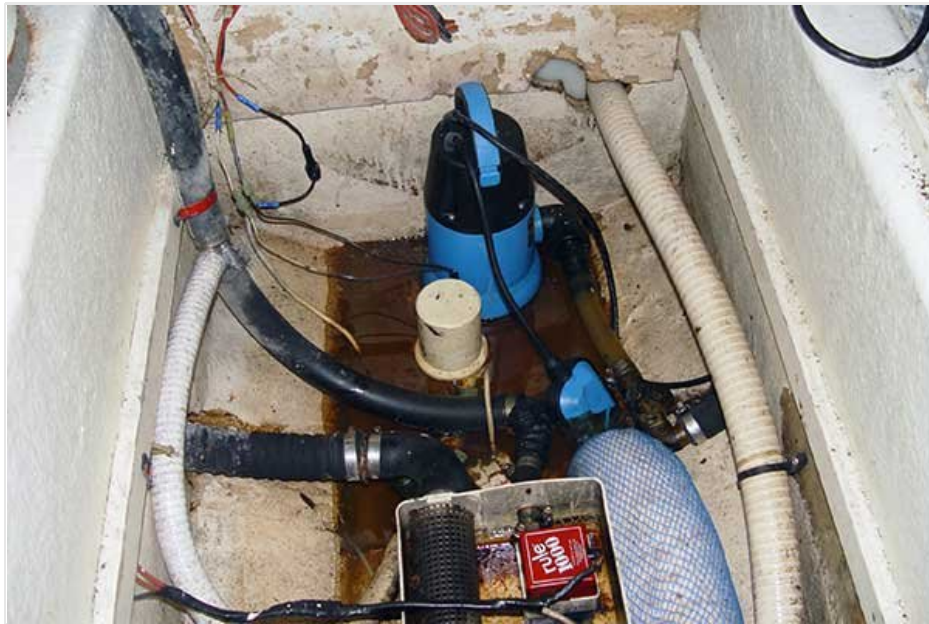
Did you find the major safety-related faults in this picture?

- 1.** The bilge pump discharge hose has been teed into the shower sump pump discharge hose; unfortunately, each can backflow into the other, rendering them useless. The surveyor who provided this picture remarked: *If one back flows into the other, you just set up a pumping loop that does nothing except aerate the bilge water and make the bilge creatures happy.*
- 2.** To try to get around #1, the installer added a check valve to each hose, which are not recommended by ABYC, partly because they can get stuck

closed — which is exactly what happened to both valves. Neither pump worked.

3. If both pumps are on, the output is funneled into a single discharge hose that is too small — like too many cars on a narrow street.

4. There is an AC-powered home sump pump in the bilge probably because: The vessel has serious problems the DC bilge pump system cannot be relied upon to handle; the DC pump(s) may not function or; the DC pump output is substandard. Surveyor's comments: *The presence of a major AC bilge pump implies that there are very likely deeper problems.*

*Bonus points if you noticed that the bilge pump switch is jammed under the shower sump discharge hose. 🚧
